PHASE I REPORT
NATIONAL DAM INSPECTION PROGRAM

Name of Dam: WALKER LAKE DAM
State & State No.: PENNSYLVANIA, 52-127
County: PIKE
Stream: WALKER CREEK
Date of Inspection: April 3, 1980

BERGER ASSOCIATES, INC.
HARRISBURG, PENNSYLVANIA

NDI-ID No. PA-00317,
DER-ID No. 52-127

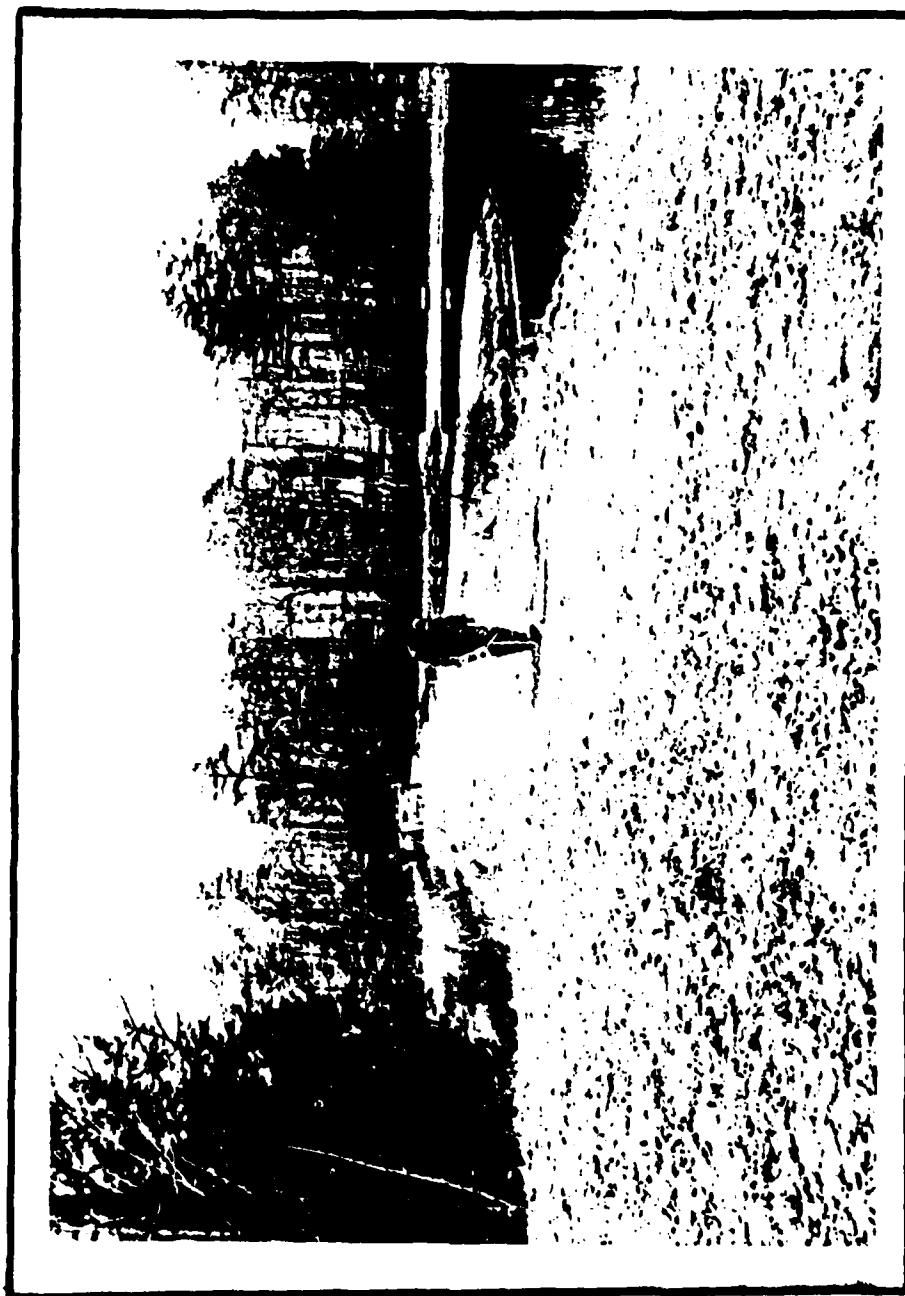
Photograph No. 1

OVERVIEW

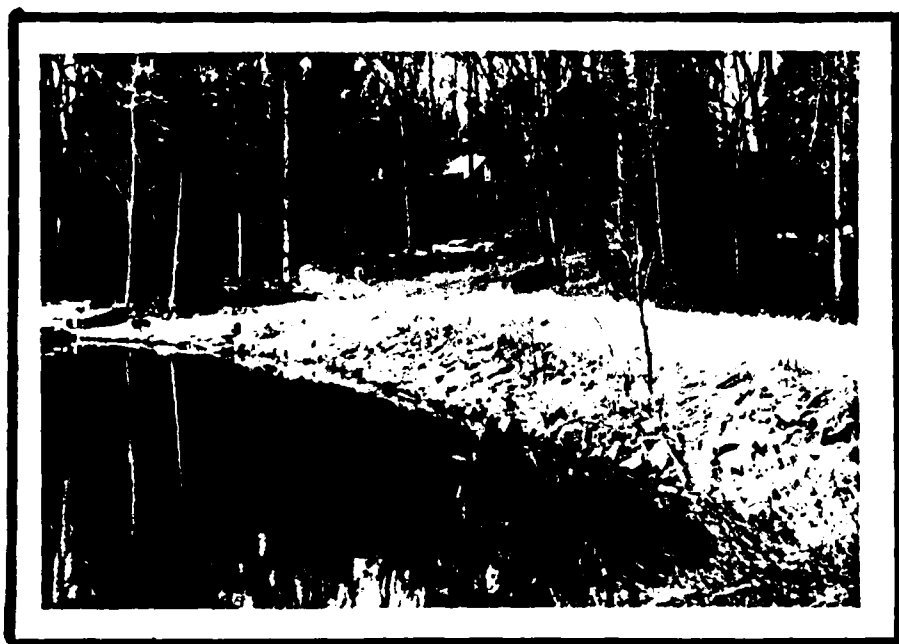
LEFT END UPSTREAM SLOPE - NO. 2

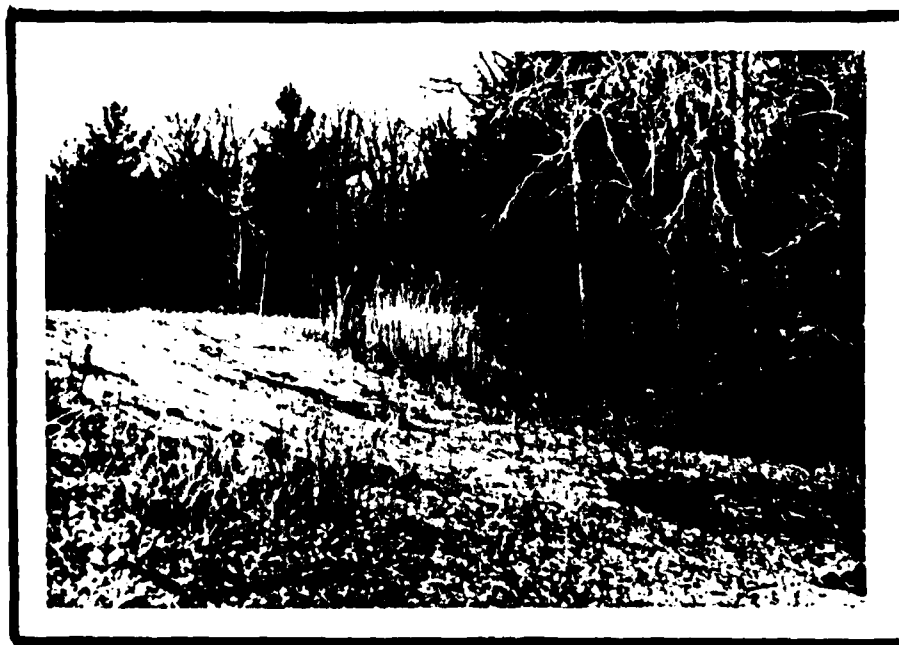
LEFT END DOWNSTREAM SLOPE - NO. 3

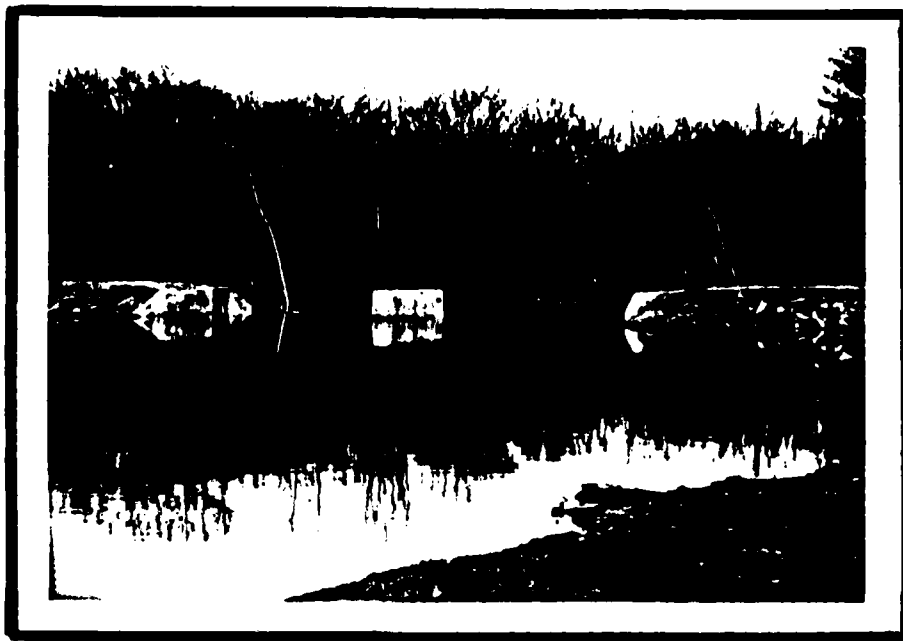
SPILLWAY FOREBAY - NO. 4

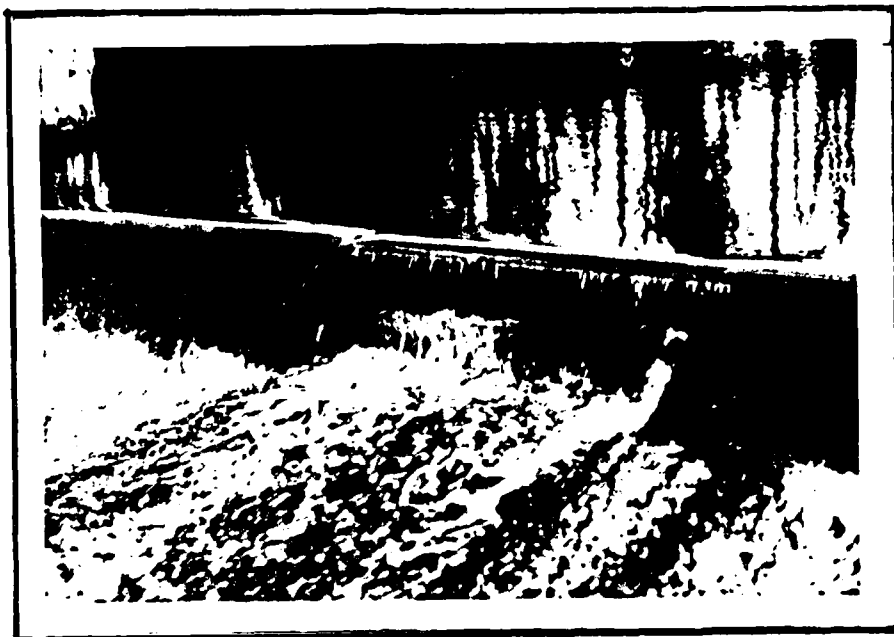
LOW FLOW NOTCH - NO. 6

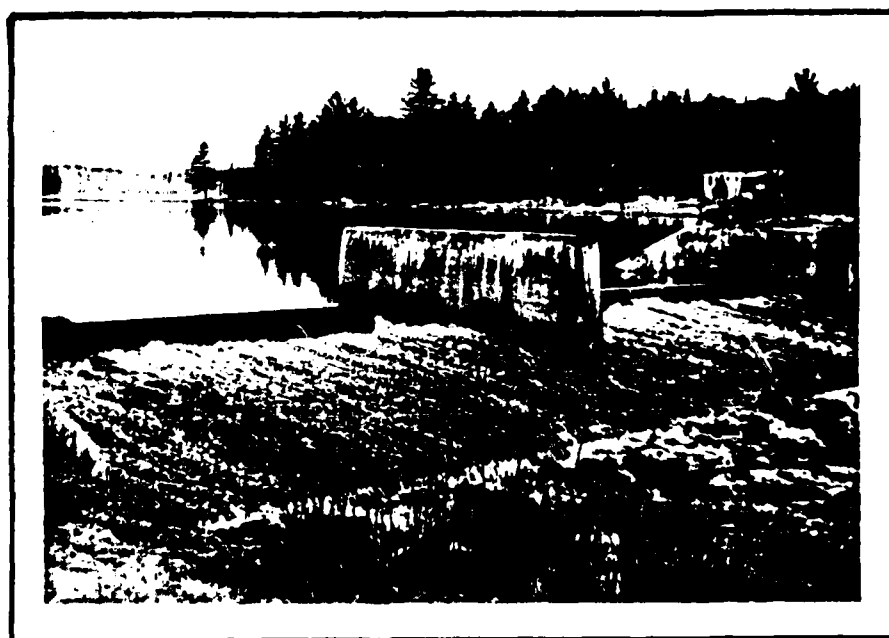
The apron immediately downstream of the spillway has been constructed with grouted handlaid stone. Several cracks and holes have formed in this apron. The immediate streambed below the apron is protected with loose riprap. The concrete of the ogee section and spillway walls show signs of deterioration (Photographs No. 5 and No. 7).

The spillway weir, downstream apron and spillway walls show signs of some deterioration. Holes and cracks in the apron should be repaired to prevent serious damage. Maintenance on the walls and weir is recommended at this time to prevent further deterioration and more costly repairs at a later date. The walls appeared to be stable at the time of inspection. There were no signs of tilting or unusual movement.

SPILLWAY APRON - NO. 7

1. That the headwall on the outlet pipe be replaced and that holes and cracks in the spillway weir and apron be repaired.
2. That the gate on the outlet pipe be maintained and operated at least once a year.
3. That all brush and high weeds be removed from the embankment on an annual basis.

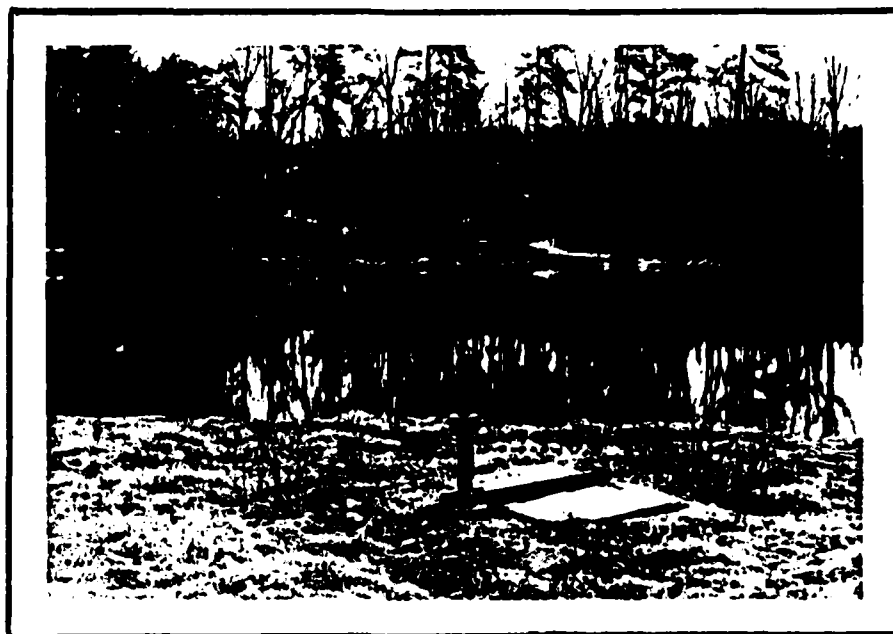
The intake structure is a wet well and was not inspected. The concrete exposed above the embankment is deteriorating on the outside face (Photograph No. 8). The headwall of the outlet pipe has collapsed and should be replaced. This will require removal of a part of the existing stone wall (Photograph No. 9).

BLOWOFF - WETWELL & VALVE STEM - NO. 8

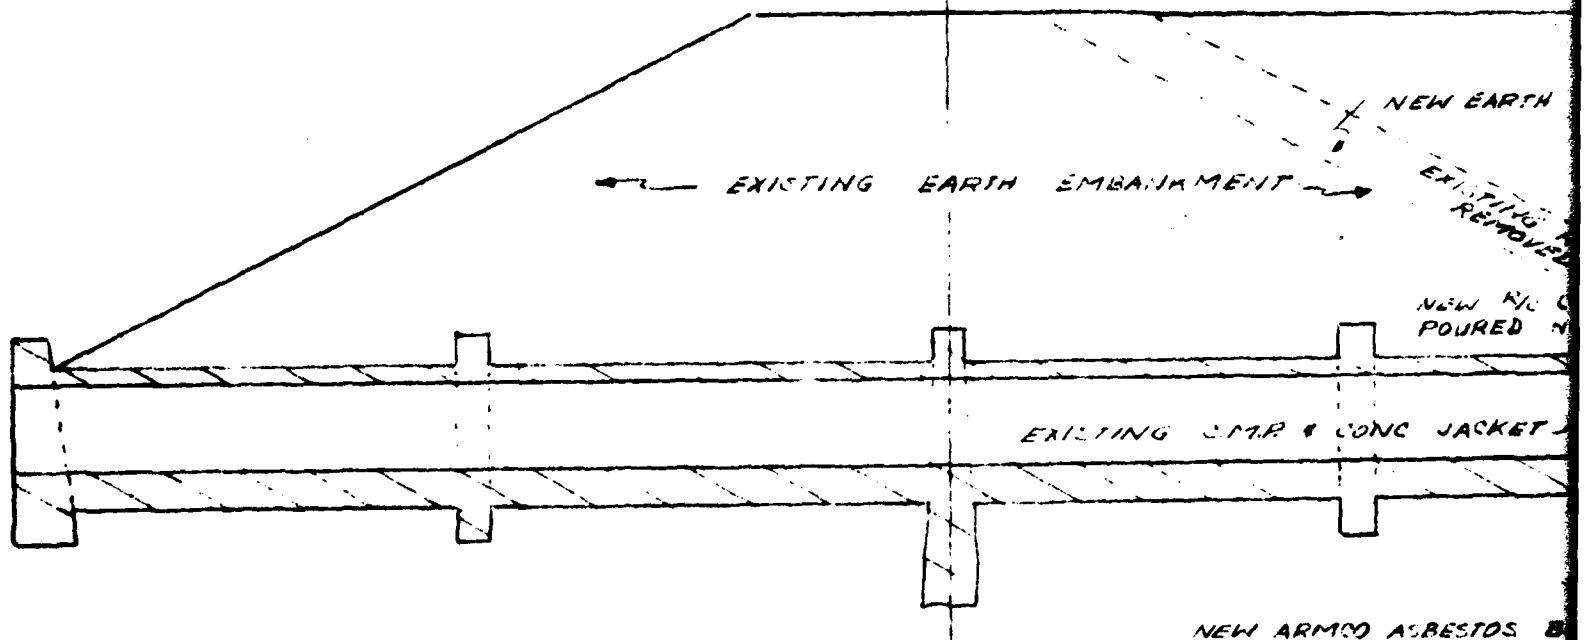
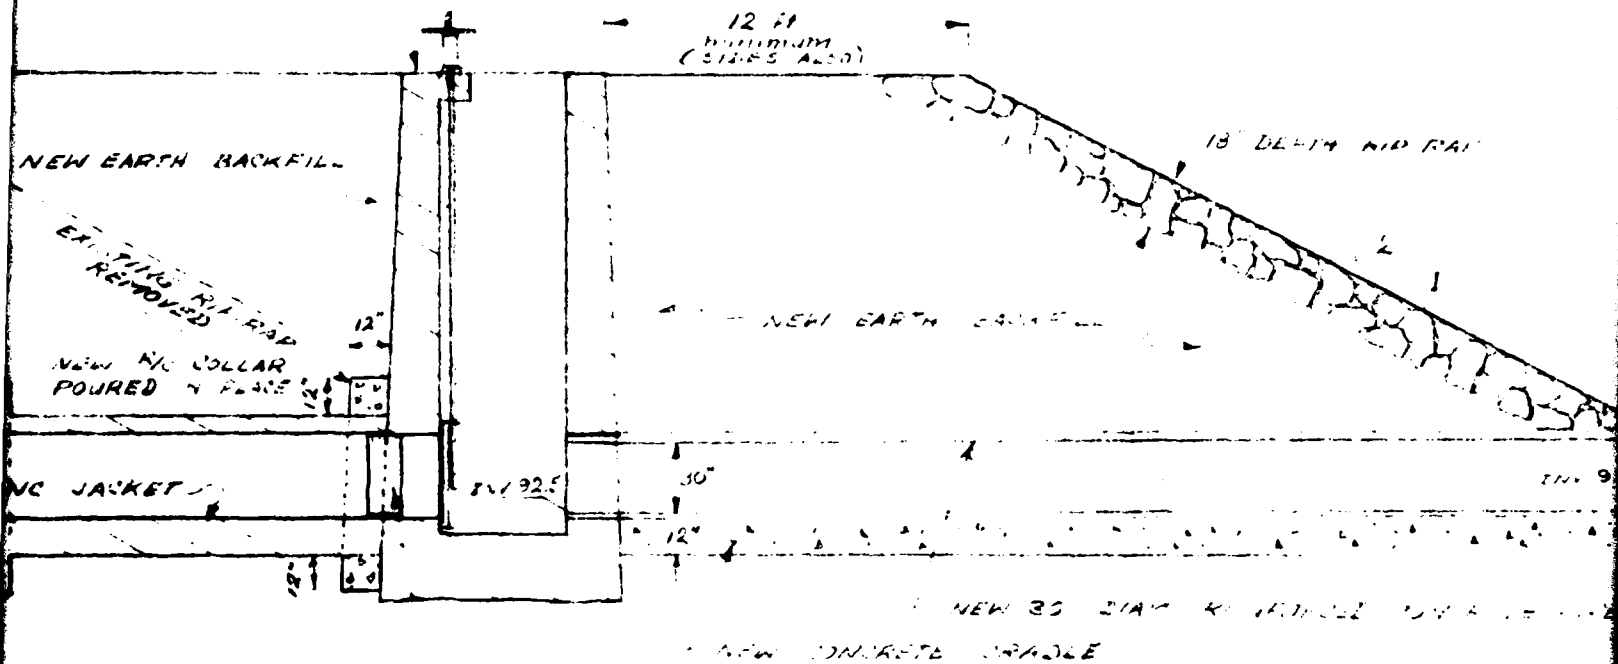
SHOWING METHOD OF REPAIR OF FAILURE AT
GATE TOWER AND OUTLET PIPE

In the winter of 1967-1968, ice pressure caused a small tilt of the intake structure, opening the joint between this structure and the outlet pipe. The joint was repaired in the fall of 1968 (Plate IV, Appendix E), and embankment fill was placed around the structure to prevent a reoccurrence of this damage.

FAILURE OCCURRED AT JUNCT
OF GATE TOWER AND OUTLET

FAILURE WAS APPARENTLY CAUSED BY TIGHTING
OF THE GATE TOWER DUE TO ICE PRESSURE
DURING WINTER OF 1967-68.

NEW ARMED ASBESTOS B
INTERNAL EXPANDING
1/8" NEOPRENE GASKET
OPENING BETWEEN TO
OUTLET PIPE.

NEW R/C COLL

For the purpose of showing the method of repair of the
failure of the outlet pipe at the gate tower of Walker Lake
on February 22, 1968, the following method of repair is shown
on this drawing.
